COLORADO GEOLOGICAL SURVEY

ROCKTALK

WHEN THE GROUND LETS YOU DOWN— GROUND SUBSIDENCE AND SETTLEMENT HAZARDS IN COLORADO

SUBSIDENCE ABOVE INACTIVE COAL MINES

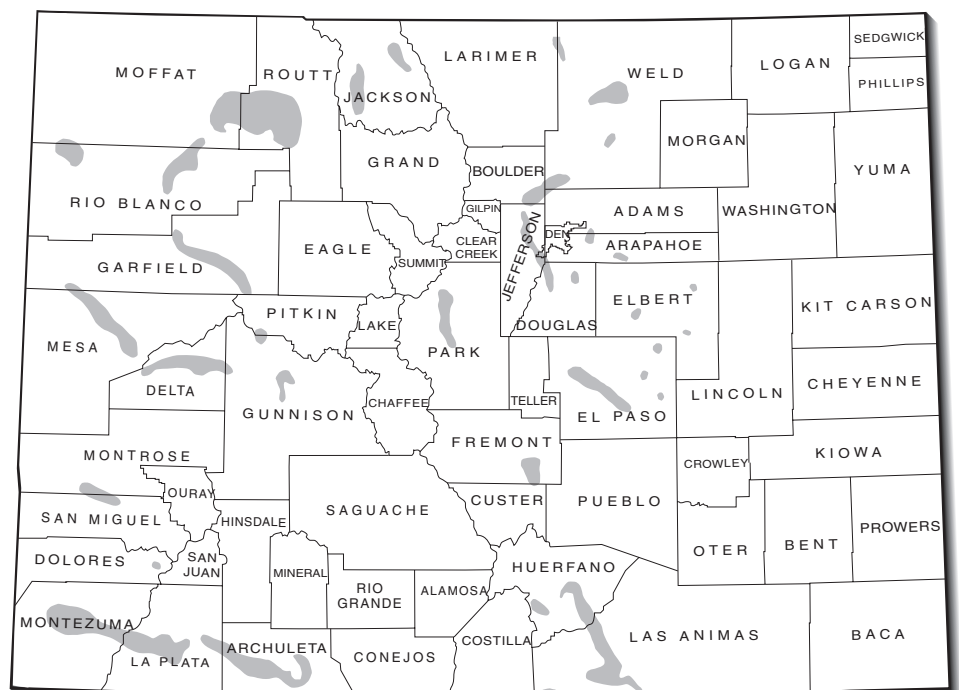
General locations of Inactive coal mines in Colorado.

an area. A name such as Coal Mine Avenue may seem fanciful rather than significant. Subsidence over abandoned coal mines is a potential hazard for thousands of homes along the Front Range Urban Corridor, and these numbers will continue to grow as more people move into the state. The map below indicates general locations of inactive coal mines throughout the state.

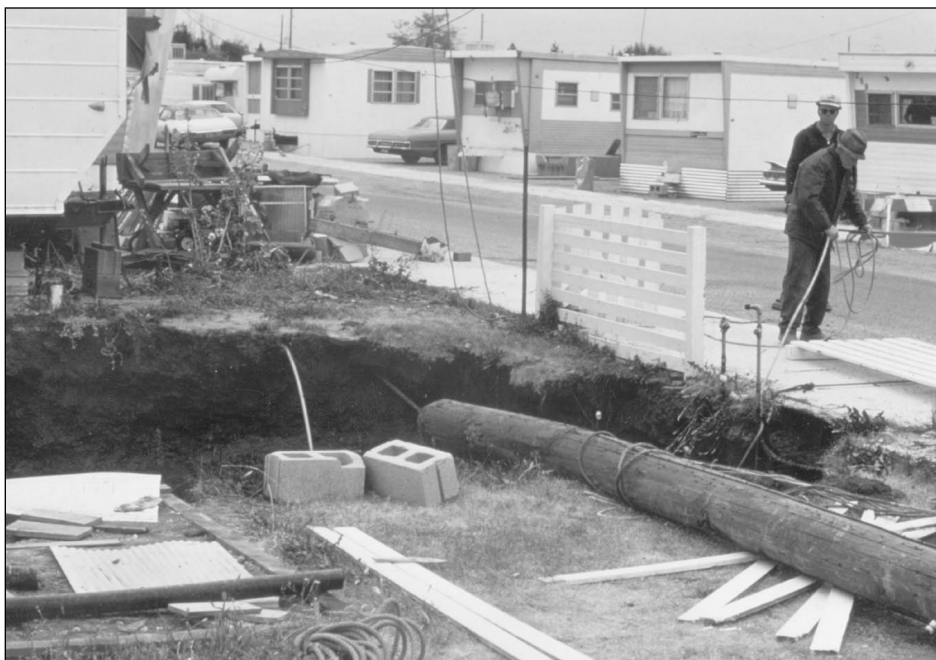
Coal mine shaft collapse in a trailer park in Colorado

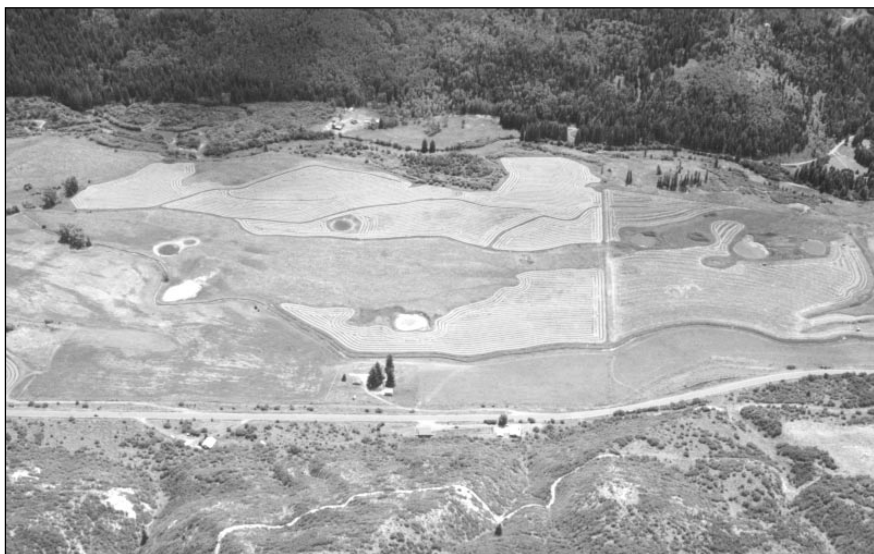
Several sinkholes give the name to Pothole Valley, east of Buford on the North Fork of the White River

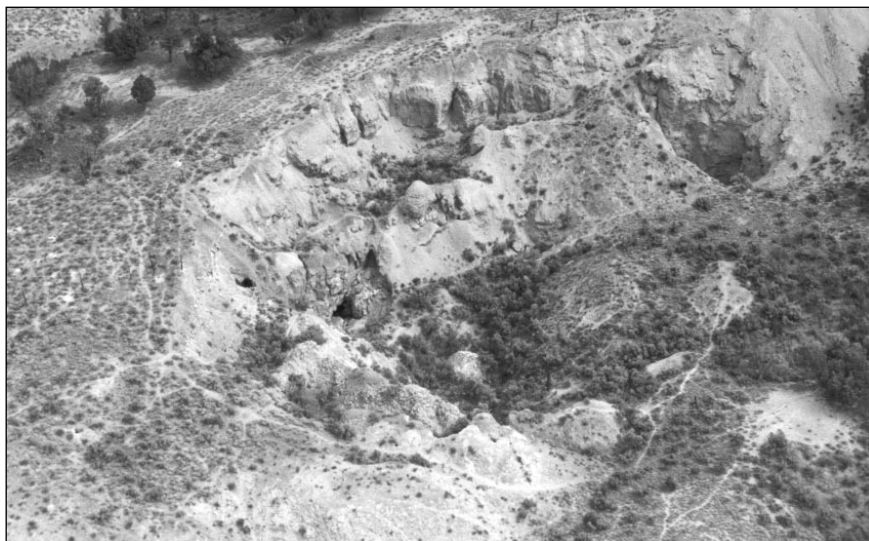
Large sinkhole (diameter approx. 200 feet) in Eagle Valley Evaporite near the Eagle County Airport outside of the town of Gypsum

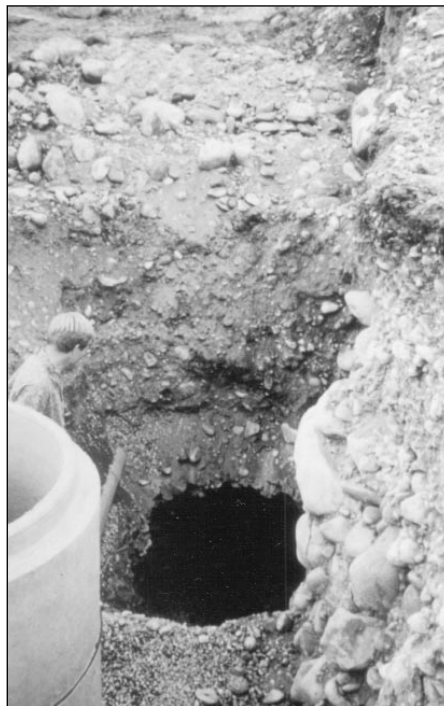
Subsurface void encountered during construction in river terrace gravel overlying Eagle Valley Evaporite—

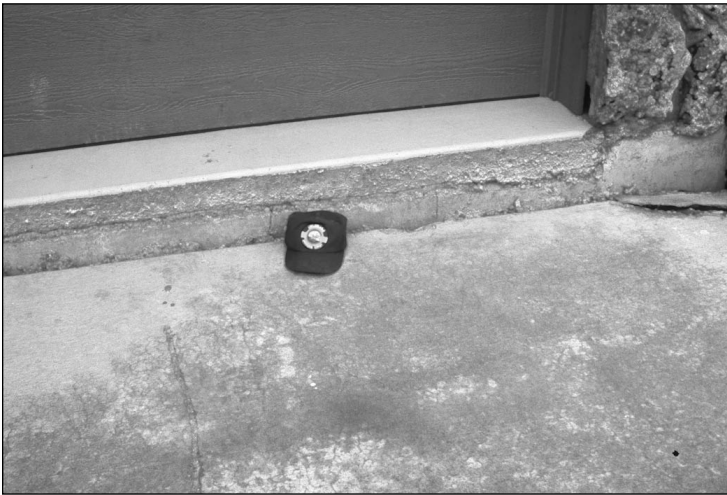
Continued settlement in collapsible soil dropped new town-home driveway to a level where vehicles are unable to enter garage. Note leveling slab of concrete on garage floor from previous repair.

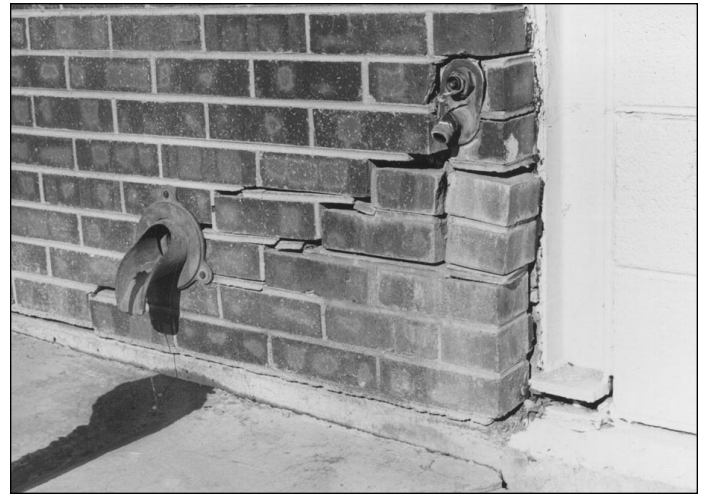
Damage to foundation and mortared brick walls from settlement of collapsible soils. Building in Montrose was demolished shortly after photo was taken. PHOTO COURTESY OF BUCKHORN GEOTECH
